Lyme, NH – Thetford, VT 14460
East Thetford Road Bridge Rehabilitation
Public Informational Meeting
October 22, 2015

East Thetford Road (VT 113) over Connecticut River

- In-depth structural inspection of all bridge components in September – October 2013
- Underwater inspection, and concrete sampling and testing of pier in August – October 2013
- Load rating analysis of the structure was completed in May 2014

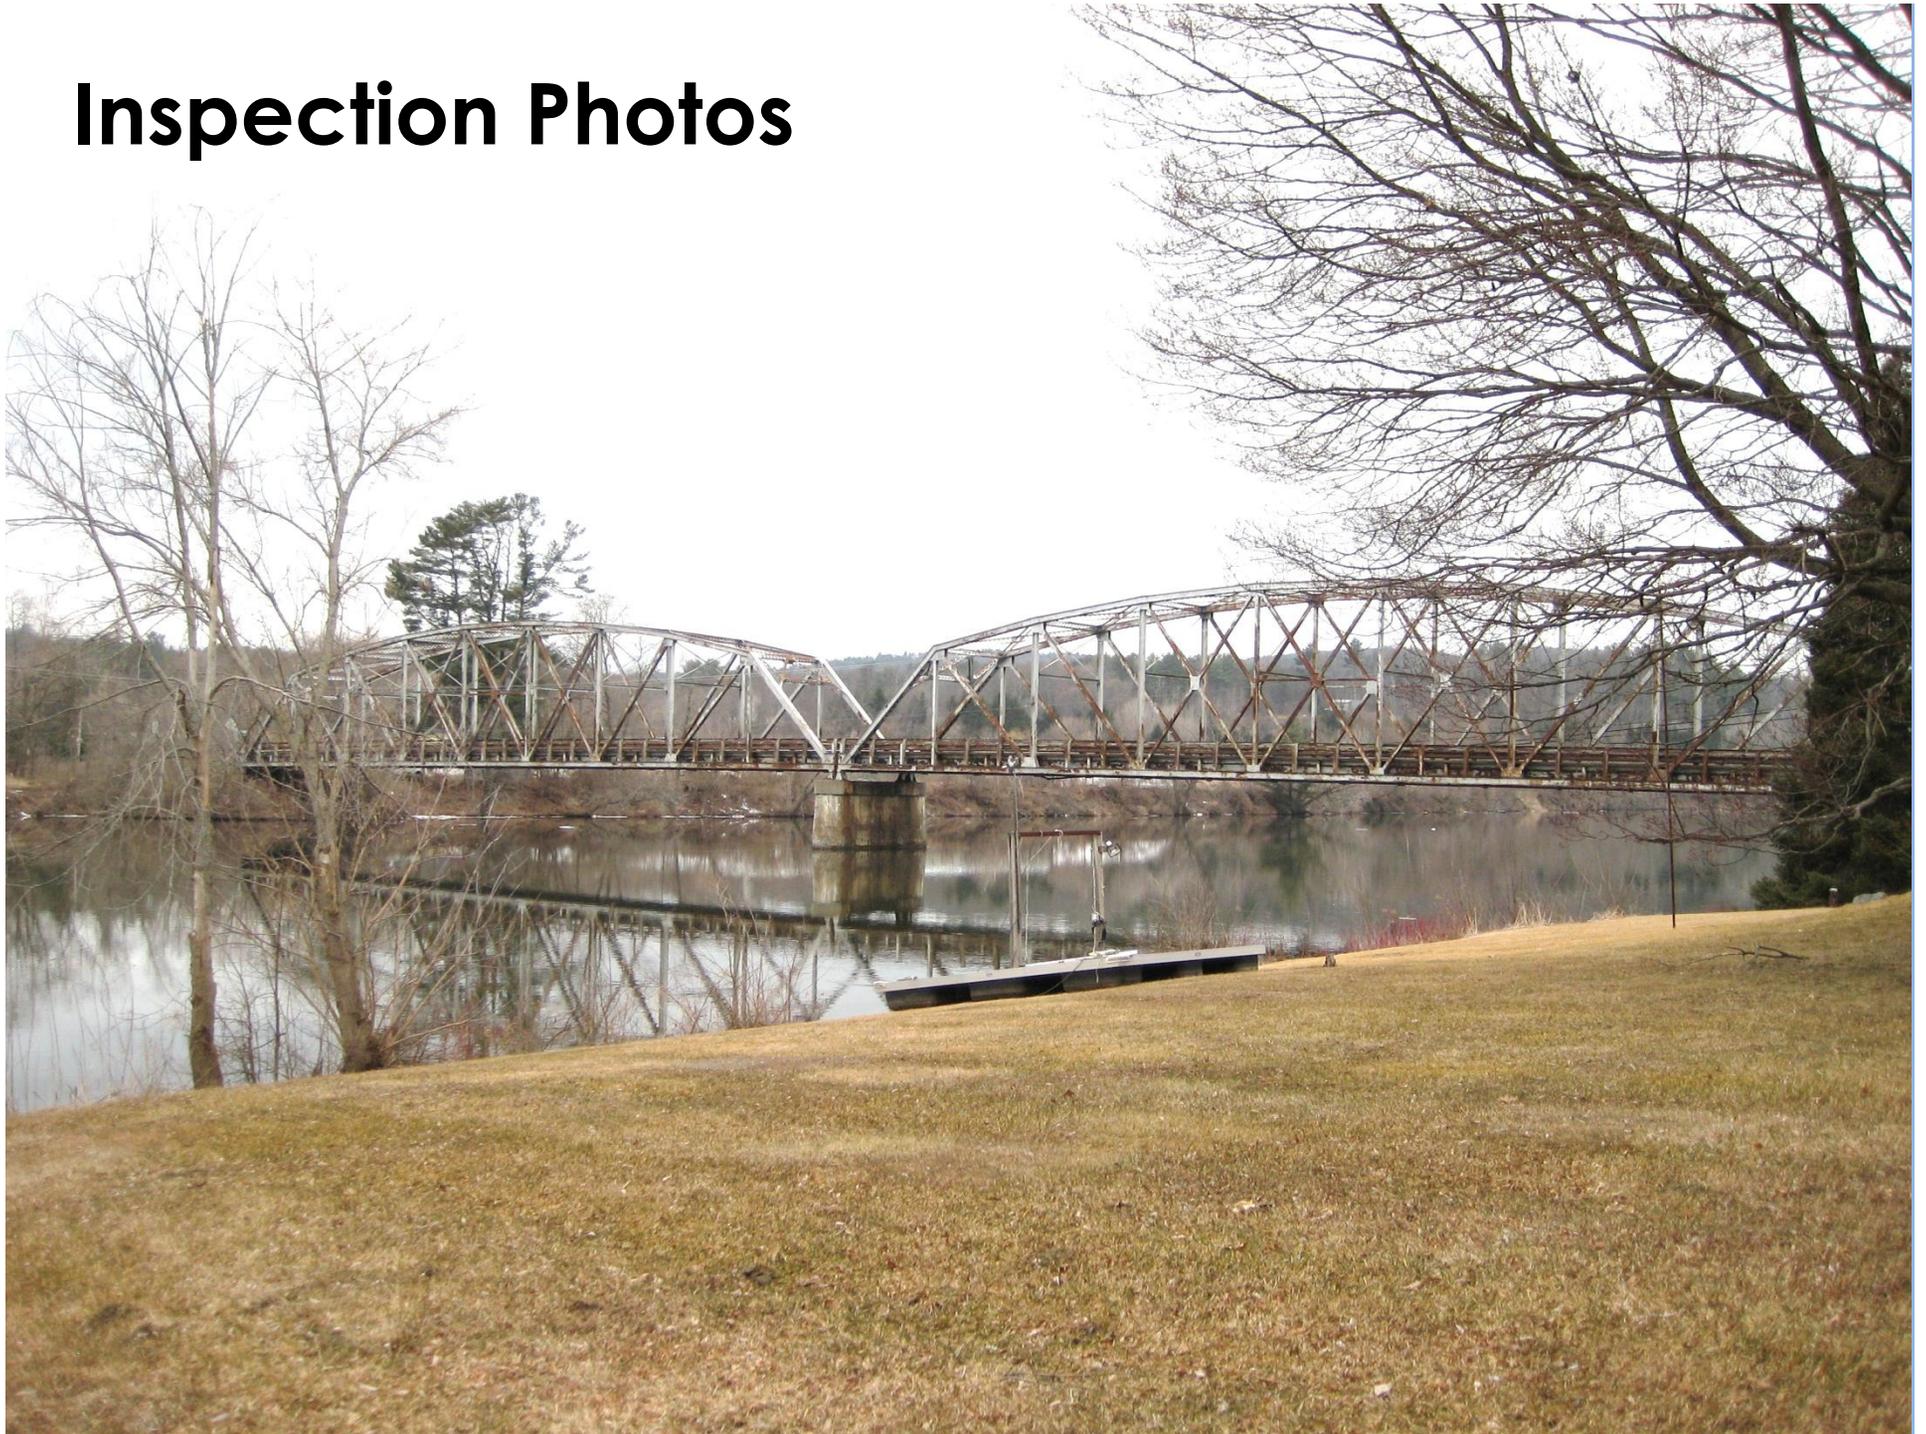
Steel Bridge Rail and Curb Deterioration

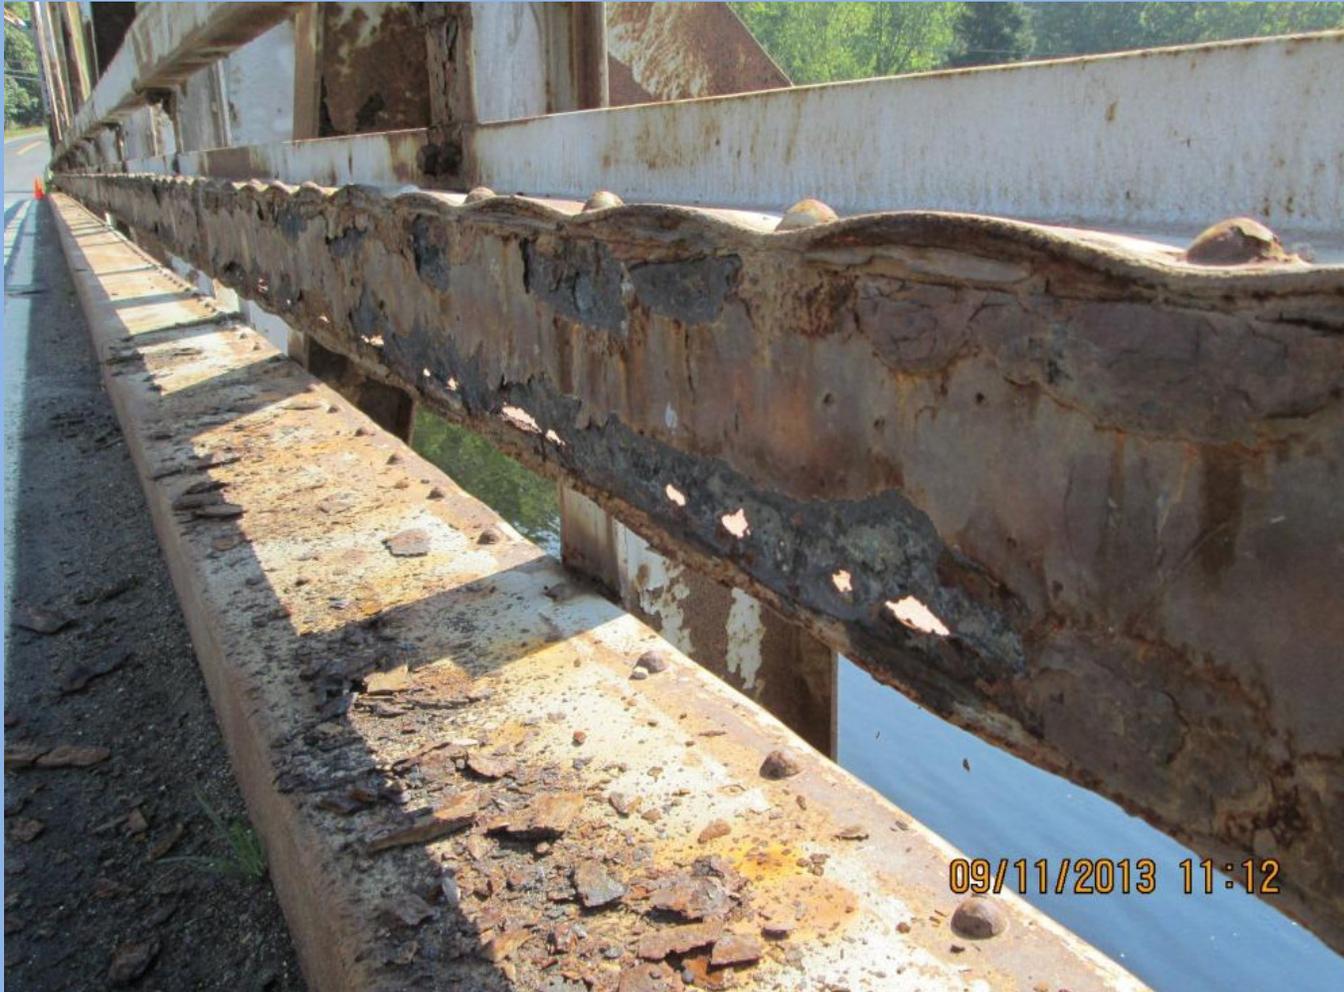
Existing Bridge Rail and Curb are in Poor Condition, Substandard, and Must Be Replaced

- The existing steel bridge rail and curb plates are in poor condition and must be replaced
- The existing bridge rail is not crash tested and does not meet current safety requirements. The design also promotes pack rust that increases maintenance costs
- The recommended bridge rail system is NHDOT T3 steel rail with posts anchored directly to concrete curbs. This rail system has been crash tested and approved by the Federal Highway Administration
- Provide proper approach railing transitions at the four corners of the bridge

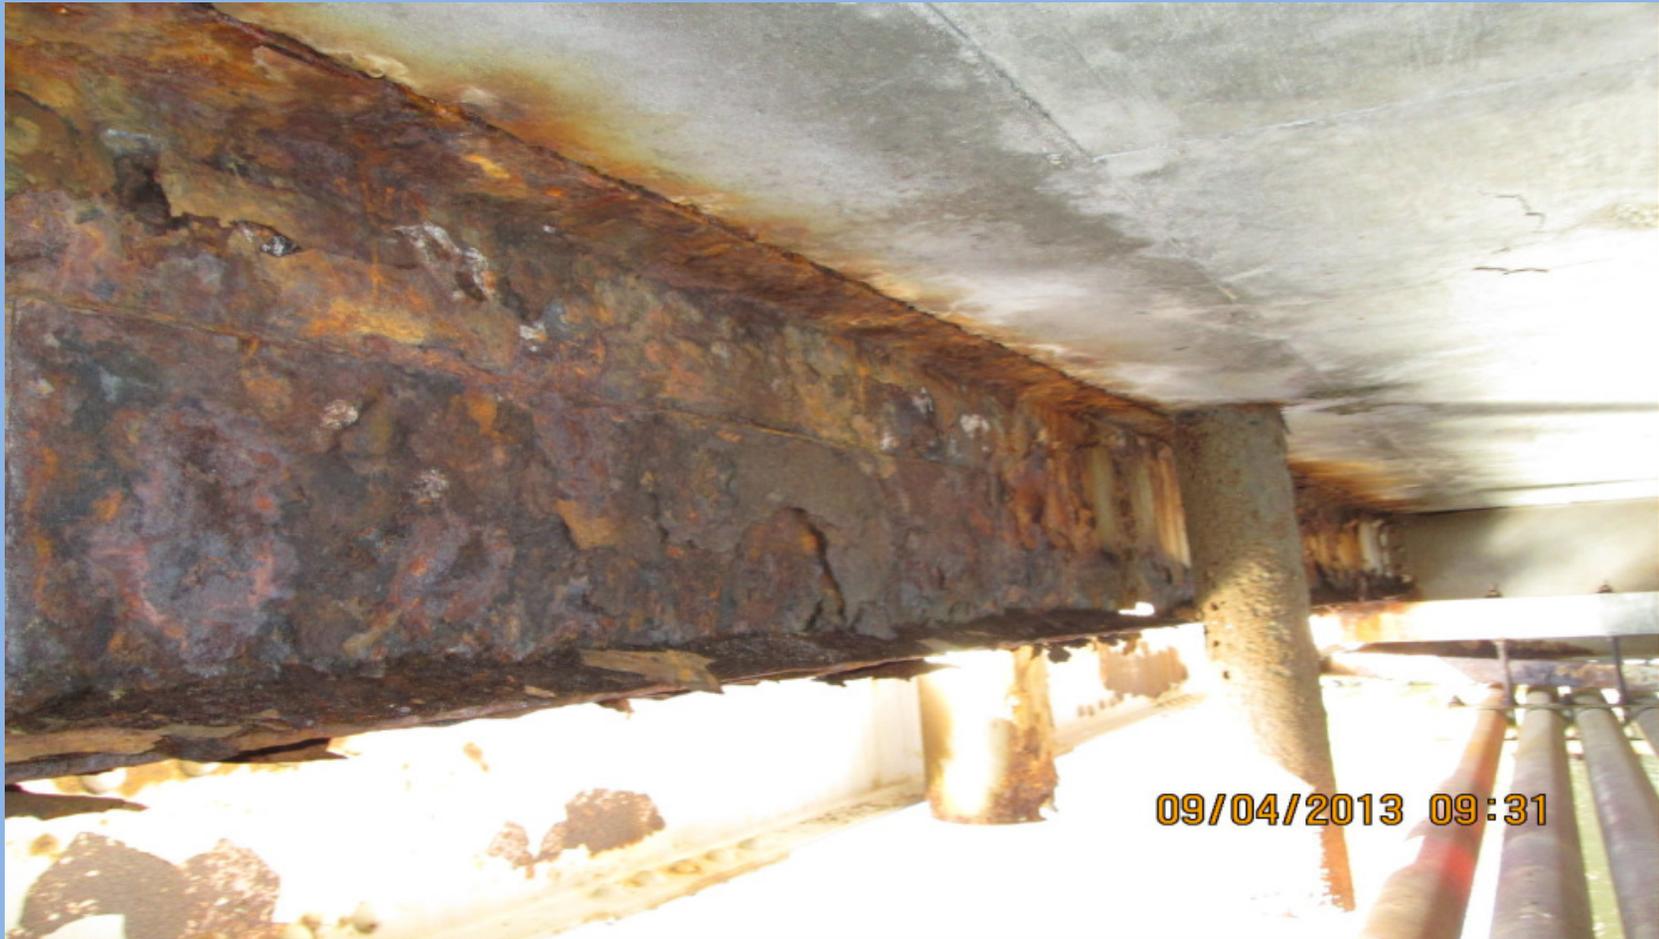
Stringer Deterioration

Many Existing Stringers & End Floor Beams are in Serious Condition and Must Be Replaced

- Due to heavy rusting and section loss many components of the floor system framing must be replaced
- The recommended rehabilitation of the floor system framing consists of replacing the exterior steel stringers (possibly others) and lateral bracing, and the end floor beams (two each span)

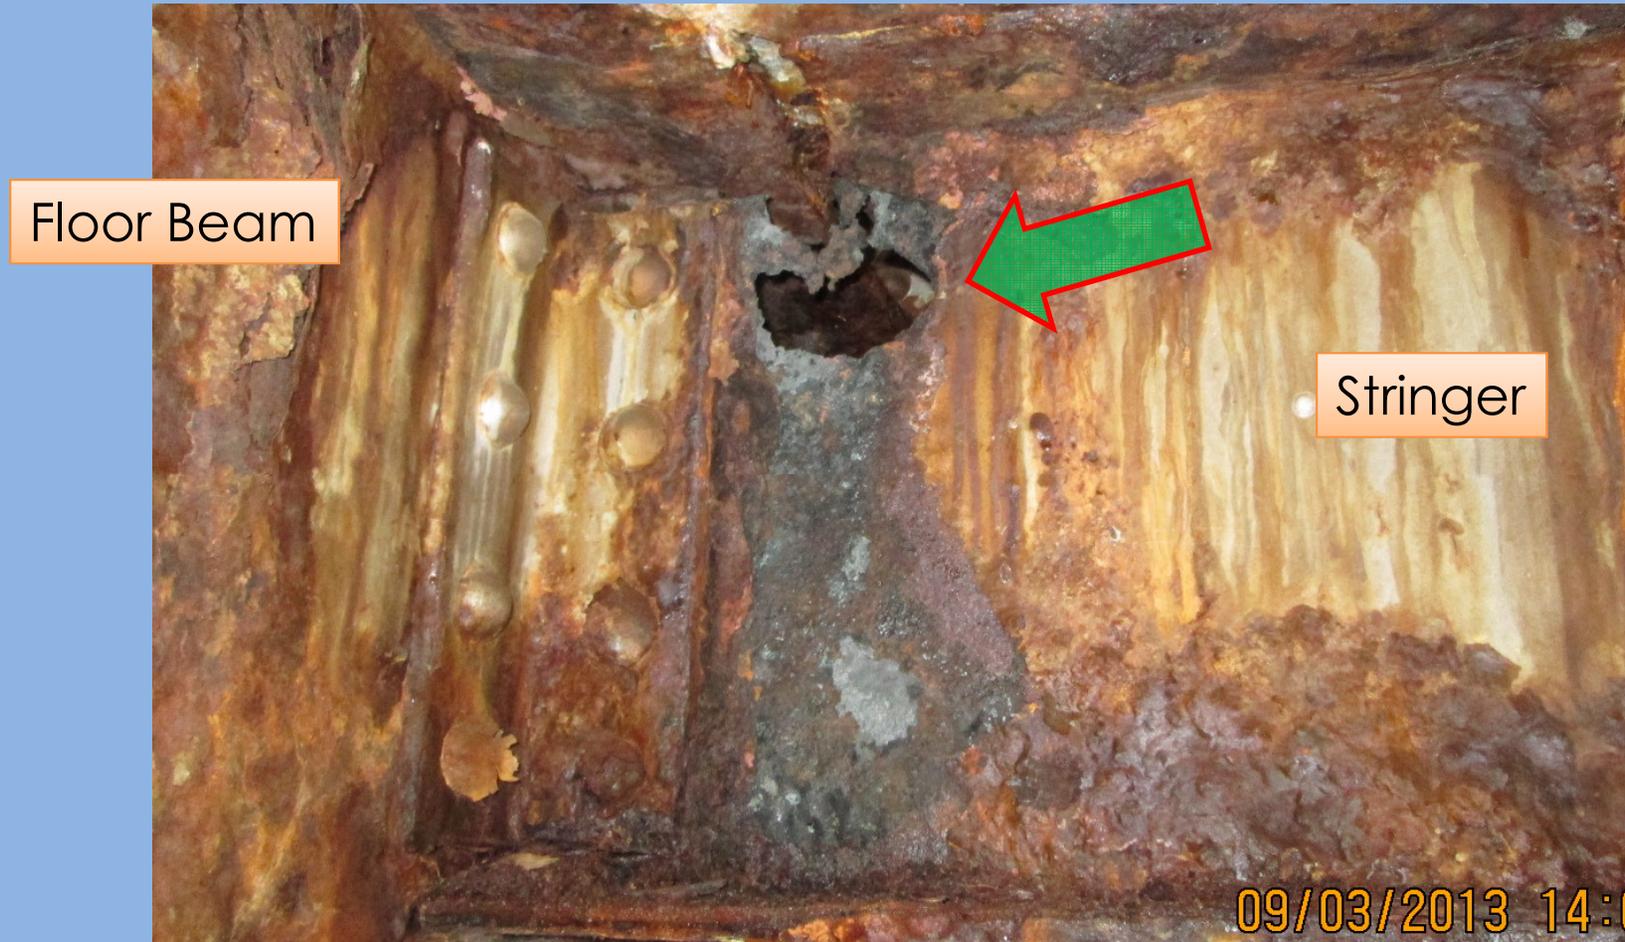
Stringer Deterioration

Connection of Stringer to Floor Beam
Span 1 Stringer 1 West Face of Floor Beam 0
Has Since Been Repaired by NHDOT Forces - Fall 2014

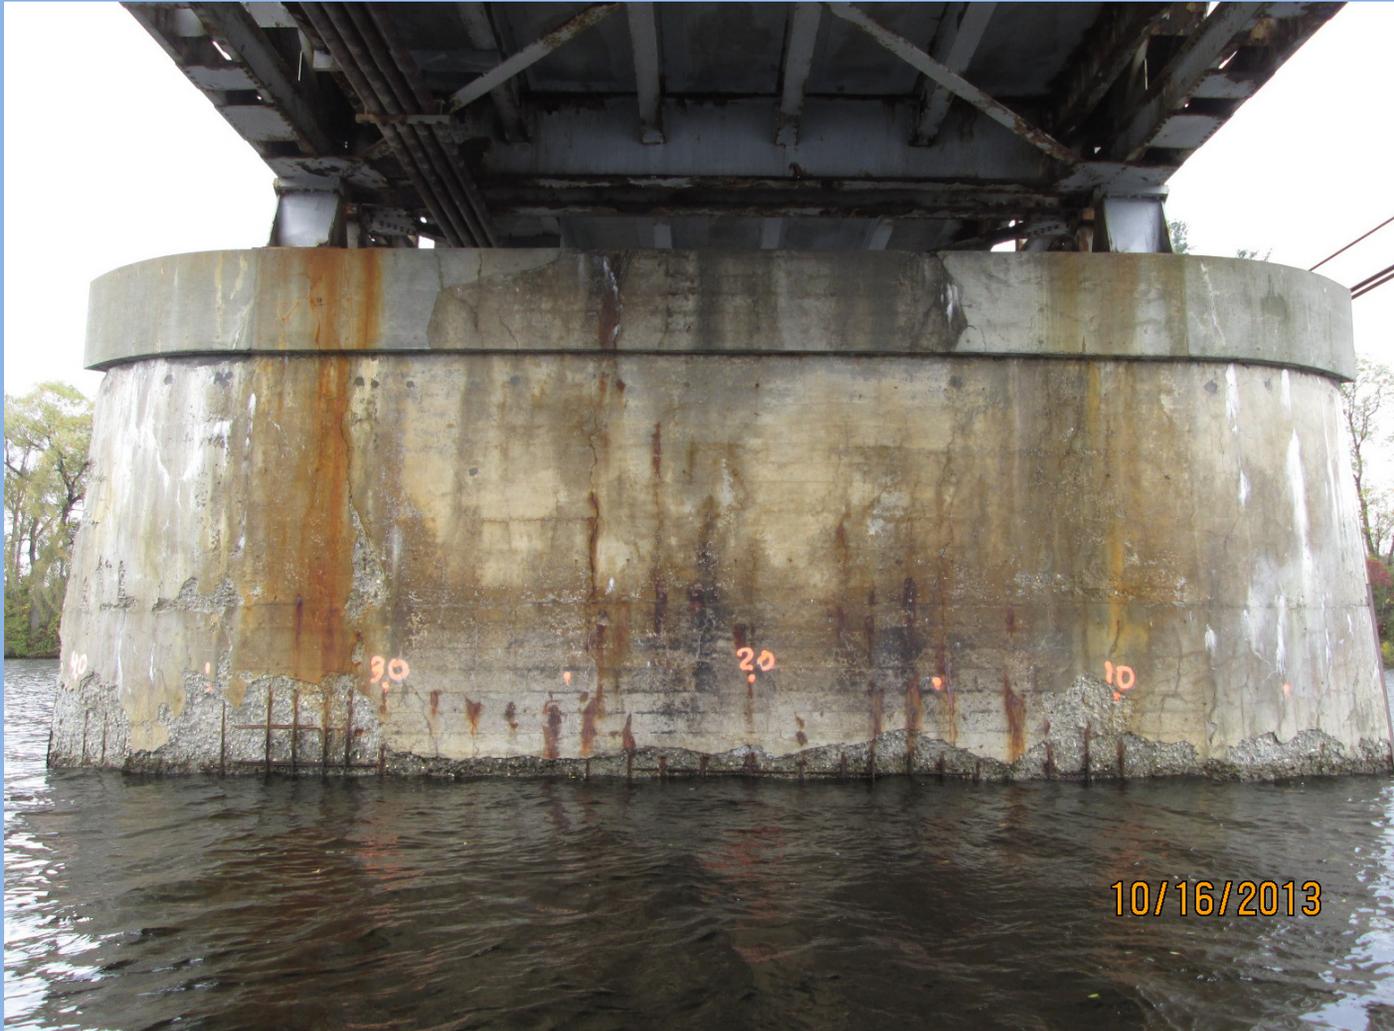
Pier – East Elevation

Extensive Cracking, Spalling Concrete and Exposed Reinforcing Steel
Concrete Core Samples Revealed ASR and Low Air Entrainment

- Cracking extends at least 8 inches in from the pier surface
- Concrete has low air entrainment making it susceptible to cracking due to freeze-thaw cycles
- Alkali silica reactivity (ASR) is present within the existing concrete aggregate. Aggregate exerts an expansive pressure causing failure of the concrete pier from within

- Due to the poor condition (extensive cracking and spalling concrete and the presence of ASR) the pier must be replaced.
- Replacement options being considered:
 - Replace pier in-kind (wall pier)
 - Replace with column and cap type pier

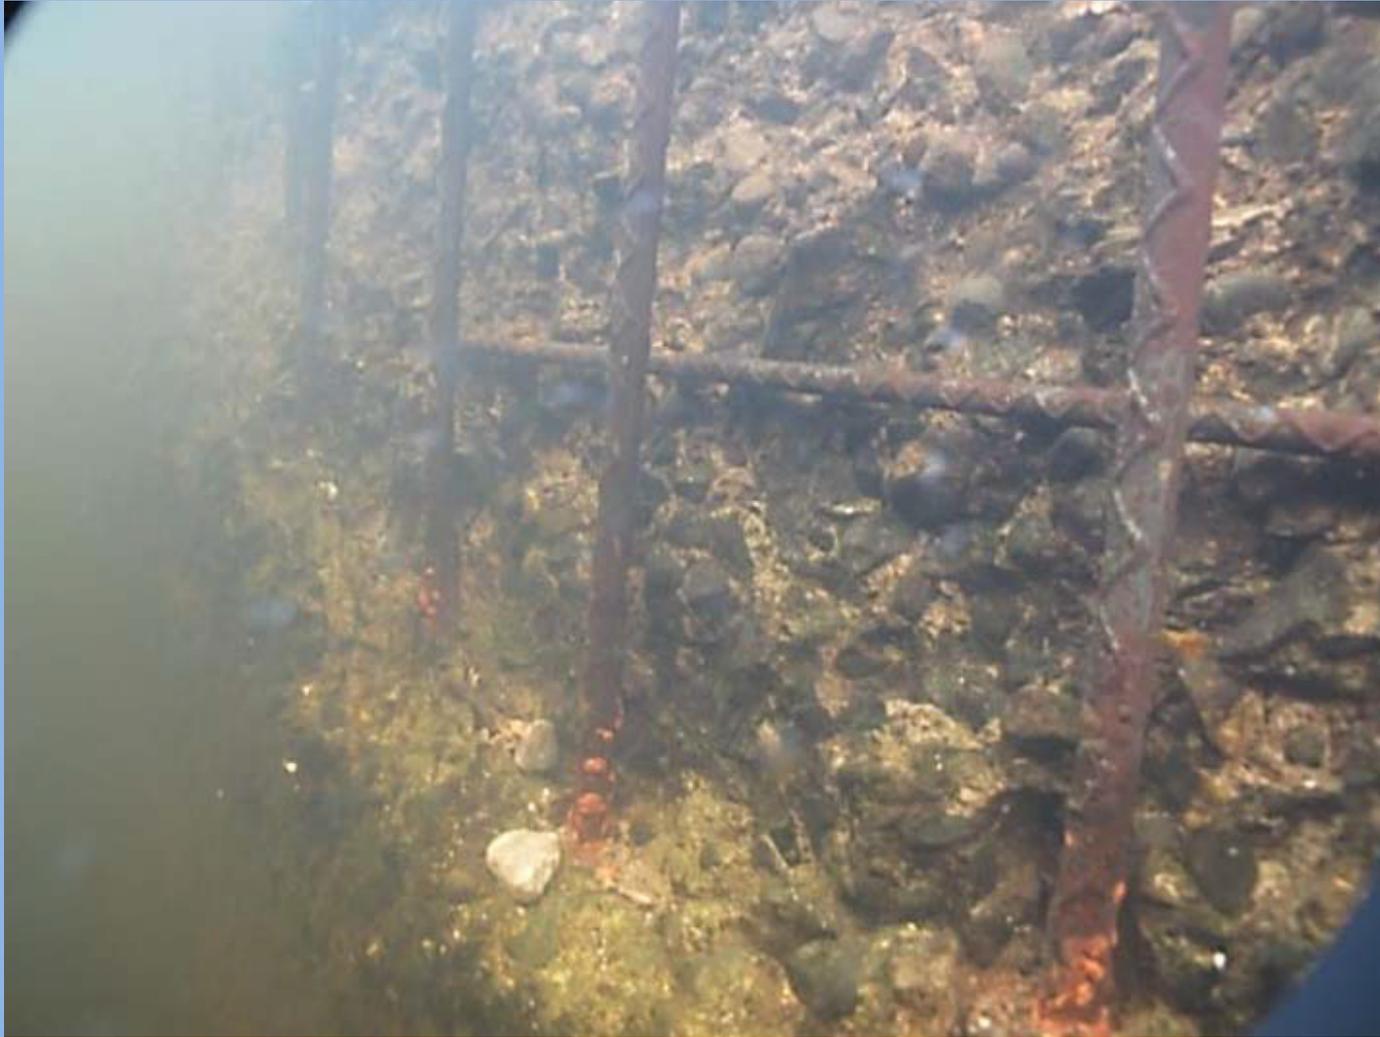
Pier – Below Waterline

Spalling Concrete and Exposed Reinforcing Steel

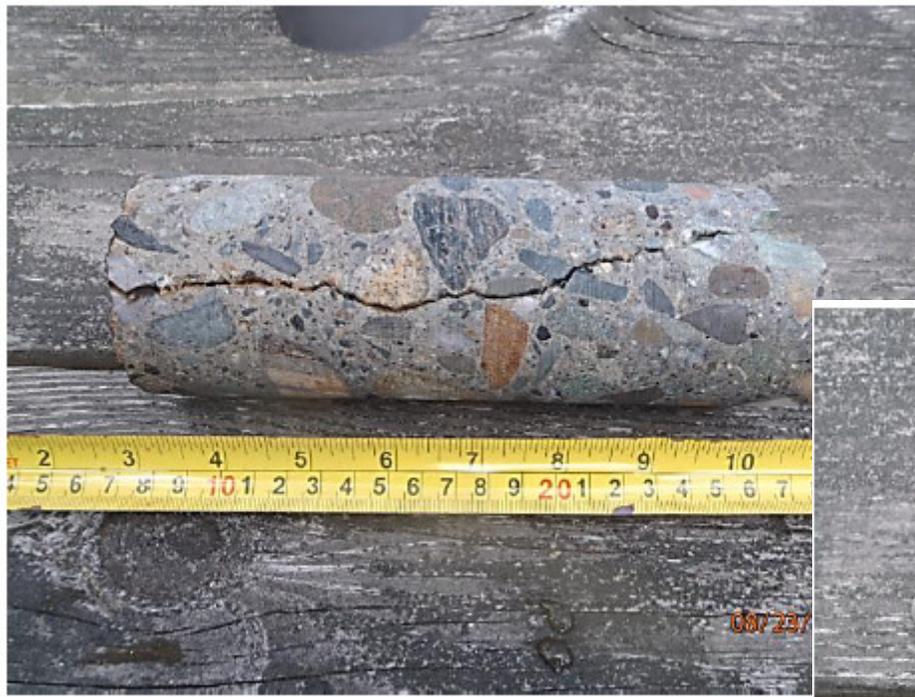
Crack Extends at Least 8 Inches From Pier Surface

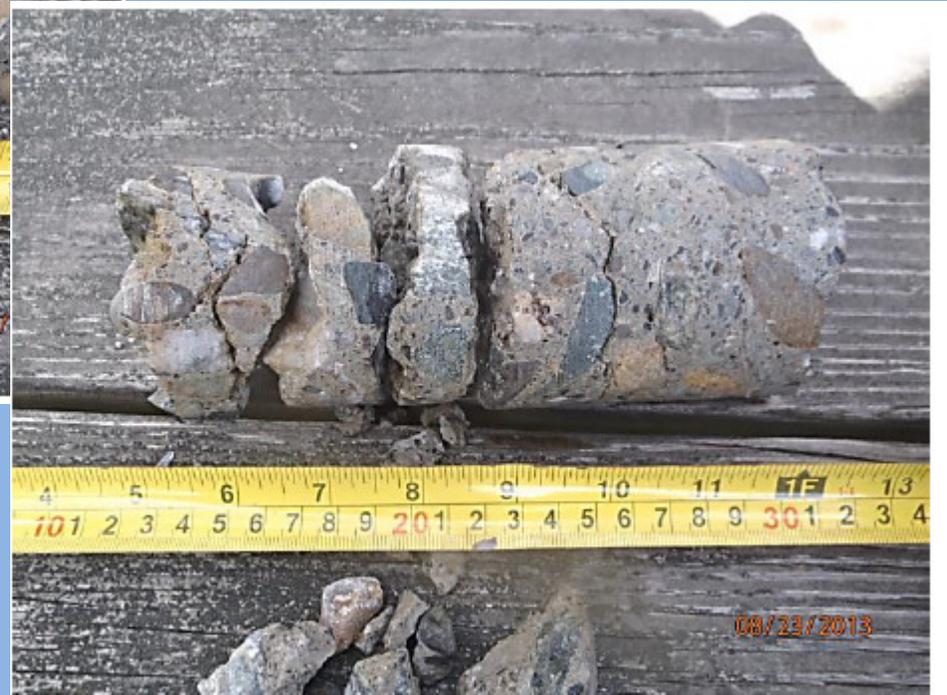
Loose Fragmented Concrete

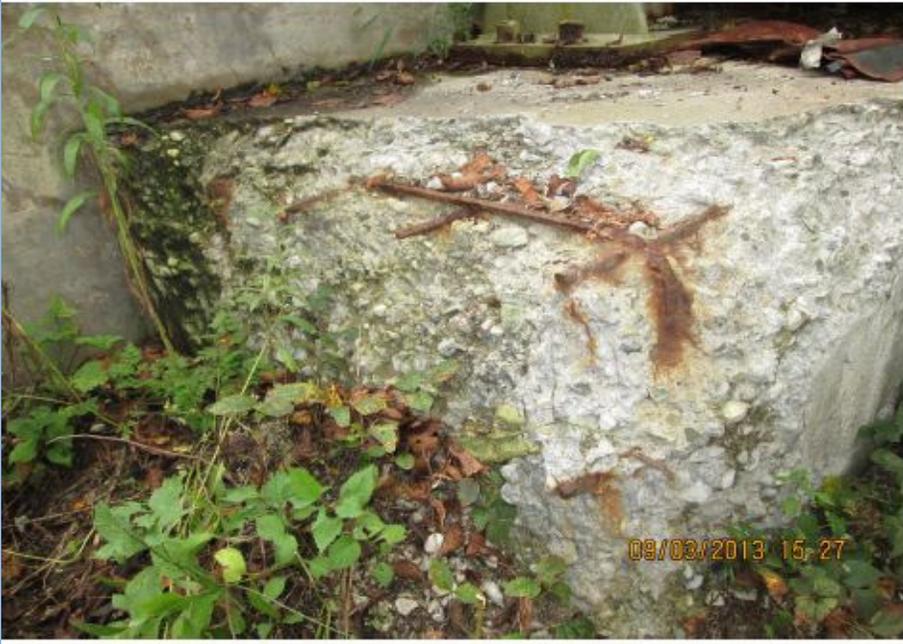
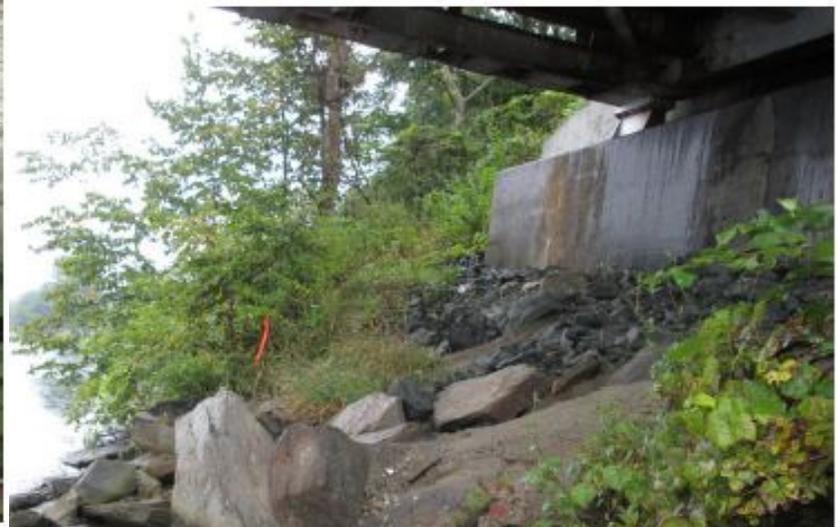
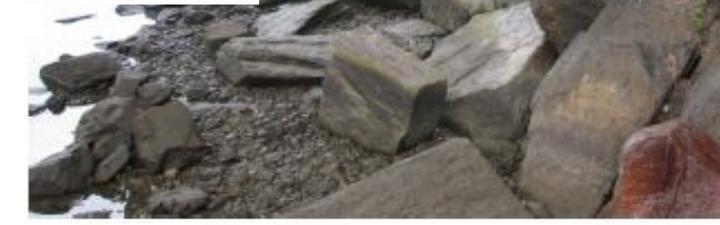
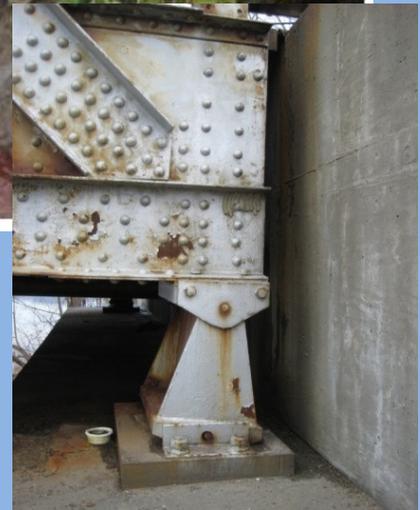
Spalling Concrete and Exposed Reinforcing Steel

- Replace the pier
- Repair the abutments
- Replace portions of the floor system framing
- Replace concrete bridge deck (roadway)
- Replace the bridge railing and steel curb
- Clean and paint all steel truss components
- Includes limited approach roadway work as necessary to provide smooth transitions to the new bridge deck

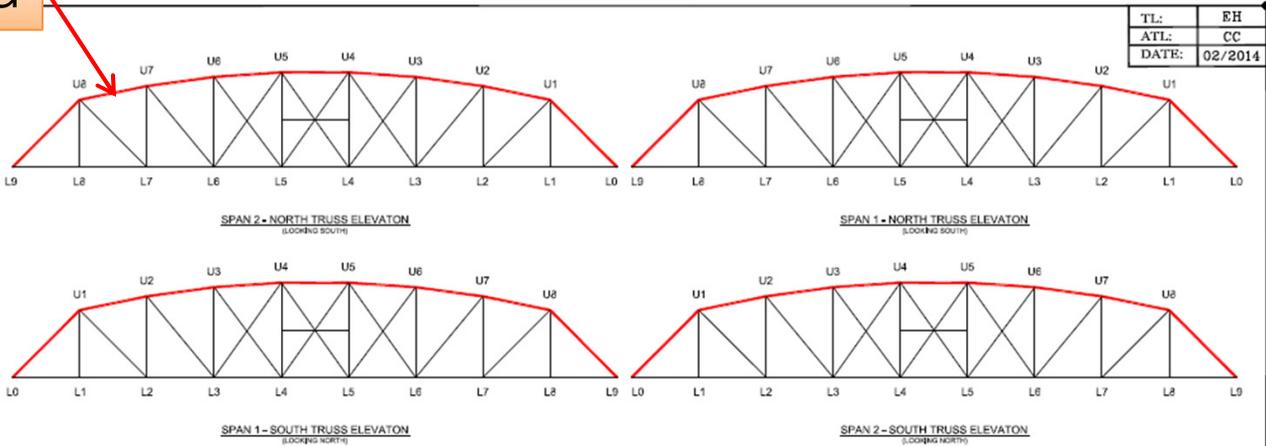
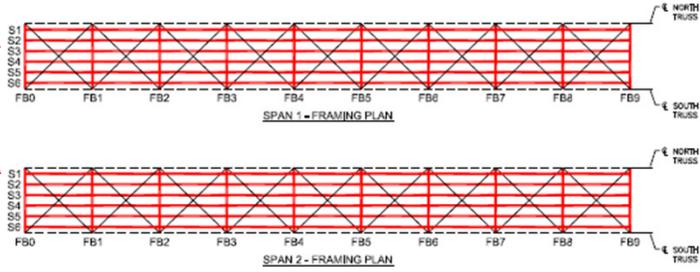
LEGEND:
 = TRUSS MEMBER, FLOOR BEAM, OR STRINGER WITH A LOAD RATING LESS THAN 1.0
